Manhole Inspection Summary

Manhole # S55C2_011MH

Location Address: **3501 Asiatic Ave.**

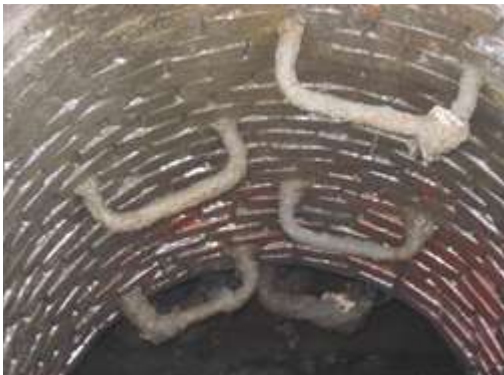
Steps Count: **7** Missing: **1** ☒ **Corroded**

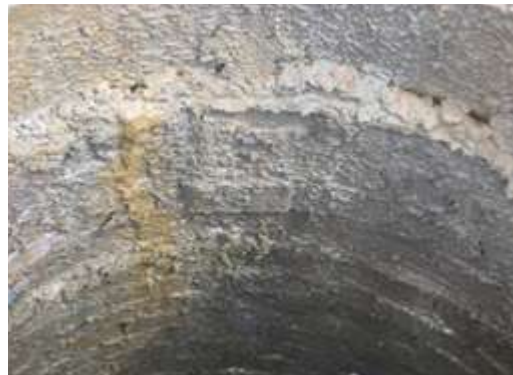
Defect 2

Infiltration: ☐ None ☒ **Joint** ☐ Cracks ☐ Mortar ☐ Roots ☐ Wall

Infiltration through the Frame-Chimney Joint

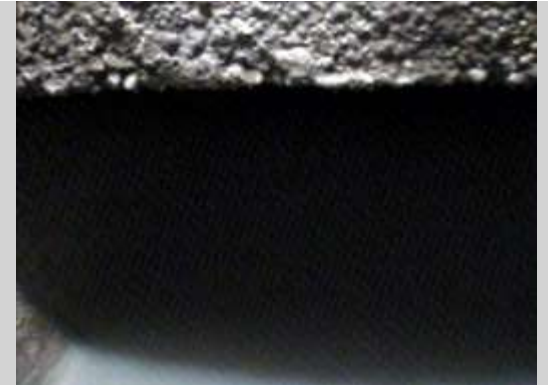
12 O'Clock Outflow

No pipe is seen except the tunnel.
